Observations of New and Reprocessed Octopus 3[®] Tissue Stabilizers and Octopus4[®] Tissue Stabilizers

The objective of this study was to evaluate new sterile and reprocessed sterile Medtronic Octopus 3[®] and Octopus 4[®] Tissue Stabilizers (see attached product PDF files). A report dated May 24, 2004 contained information and data describing the differences observed between new sterile and reprocessed sterile Medtronic Octopus 3[®] and Octopus 4[®] Tissue Stabilizers. In that report a total of four devices were assessed, one new sterile Medtronic Octopus 3[®], one new sterile Medtronic Octopus 4[®], one reprocessed sterile Medtronic Octopus 3[®] (SterilMed) and one reprocessed sterile Medtronic Octopus 4[®] (Alliance). Subsequent to that report, eight additional reprocessed Medtronic Octopus 3[®] and Octopus 4[®] Tissue Stabilizers from the same two reprocessors were examined using similar microscopic and molecular techniques. On June 7, 2004 the additional reprocessed Medtronic Octopus 3[®] and Octopus 4[®] Tissue Stabilizers were received. Results of eight of those are contained in this study for a total of twelve devices, two new sterile devices and ten reprocessed devices.

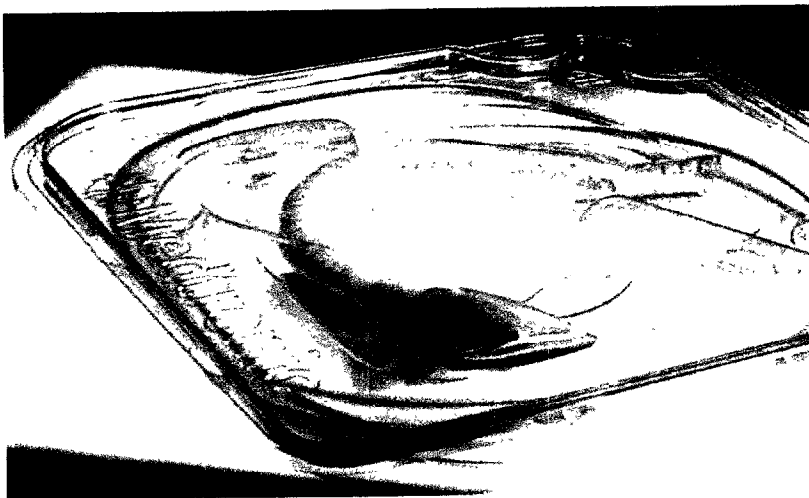
Figure 2. Example of Octopus 3® - Medtronic Sales Stock – indicated as sterile, unopened from the warehouse. Outer packaging removed (MT-104-1).

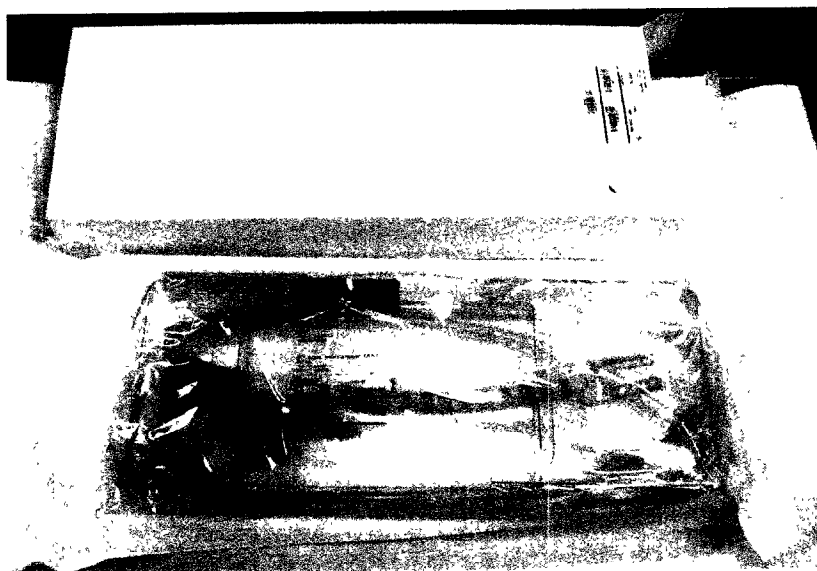
Figure 3. Example of Octopus 4® - used and reprocessed device and packaging. Outer packaging removed (MT-104-4).

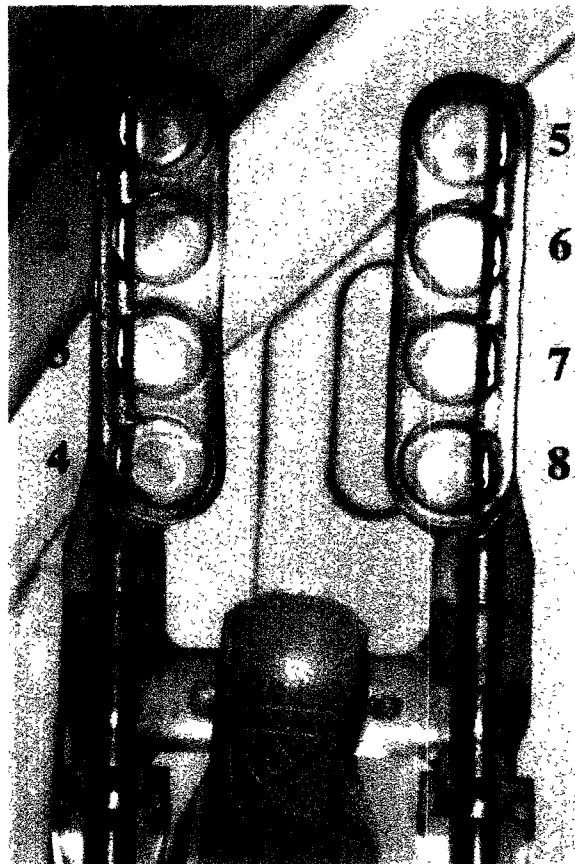
Figure 5. Overview of headlink region of an Octopus3[®] (MT-104-1). Numbers indicate pod number referenced in this report for both Octopus3[®] and Octopus4[®] devices.

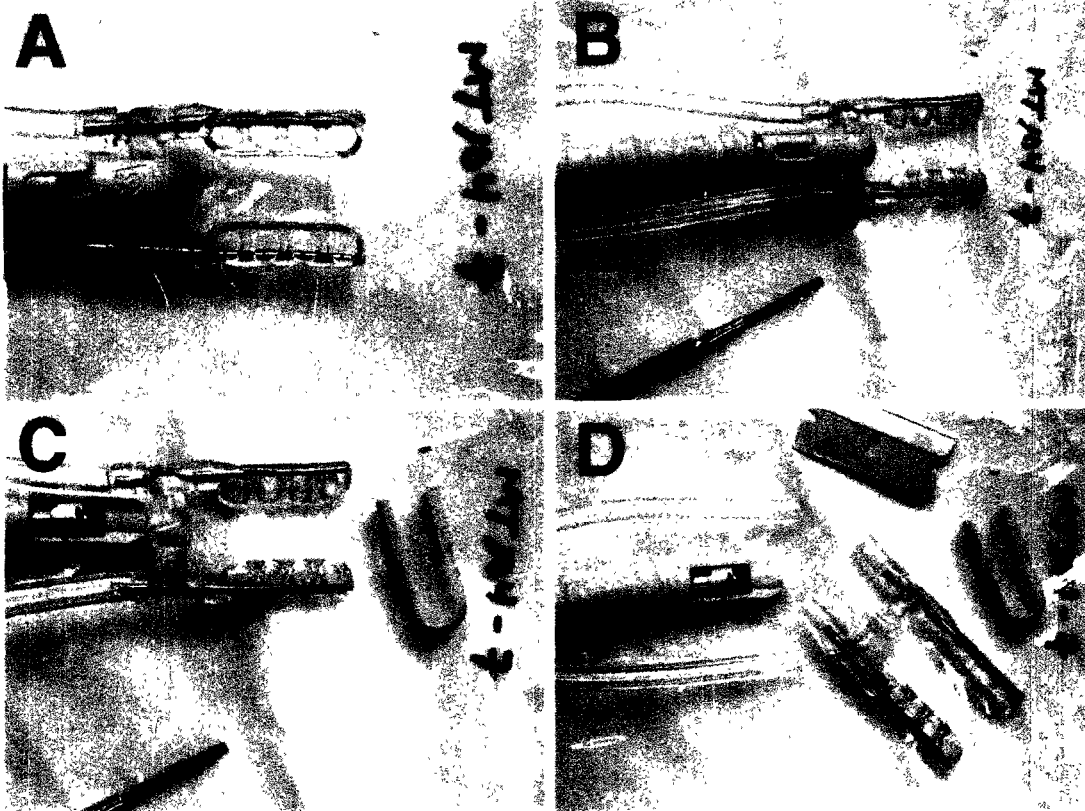
Figure 7. Example of pod - headlink dismantling (MT-104-7). All Octopus[®] devices were dismantled in a similar manner. This permitted viewing of the interior of hypotubes and ball joint regions as well as observation in the variable pressure scanning electron and confocal microscopy.

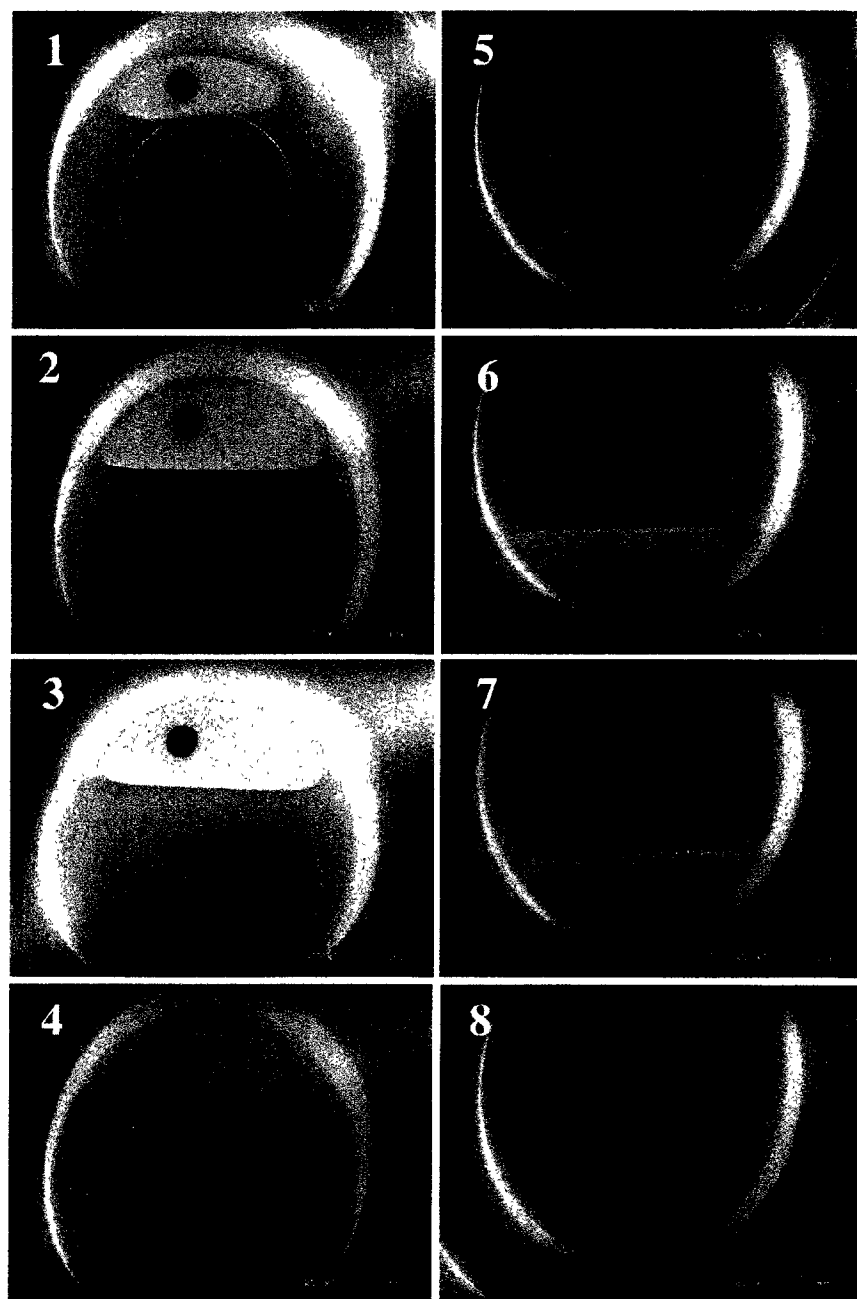
Figure 15. Series of images collected from Hitachi S3500N variable pressure scanning electron microscope in the areas of the pods on the **new Octopus 3[®] (MT-104-1)**. The images show uniform surface structure in the wells and tubing. There are what appear to be small pieces of the same material as the pod in some wells (e.g. #2 and #6). The numbers indicate the pod # (see Figure 5). Scale bar in each image.

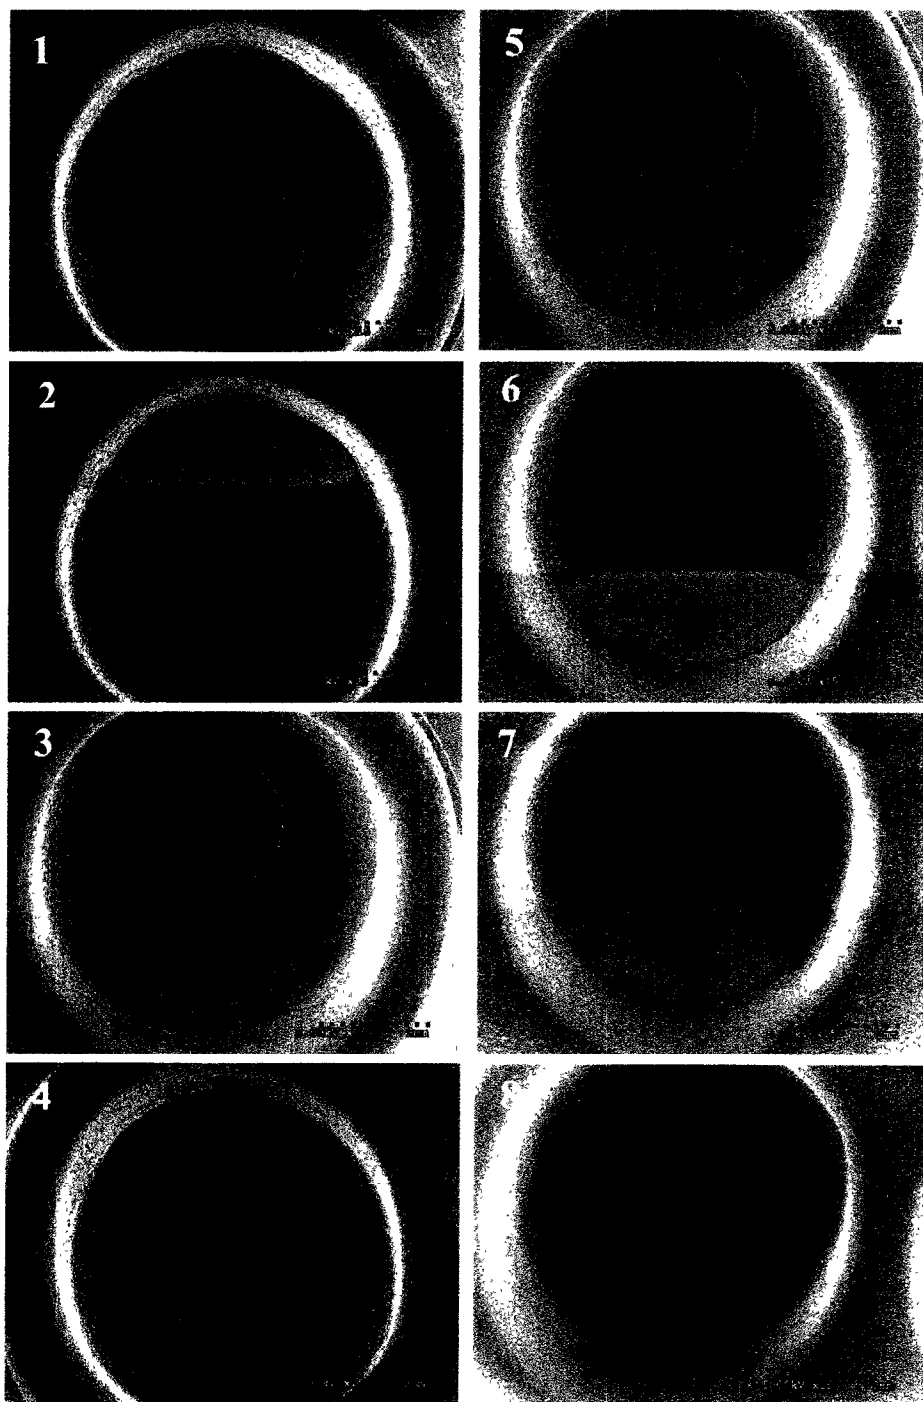
Figure 18. Series of images collected from Hitachi S3500N variable pressure scanning electron microscope in the areas of the pods on the **new Octopus 4[®] (MT-104-2)**. The images show uniform surface structure in the wells and tubing. There are what appear to be small pieces of the same material as the pod in some wells (e.g. #1 and #7). The numbers indicate the pod # (see Figure 5). Scale bar in each image.

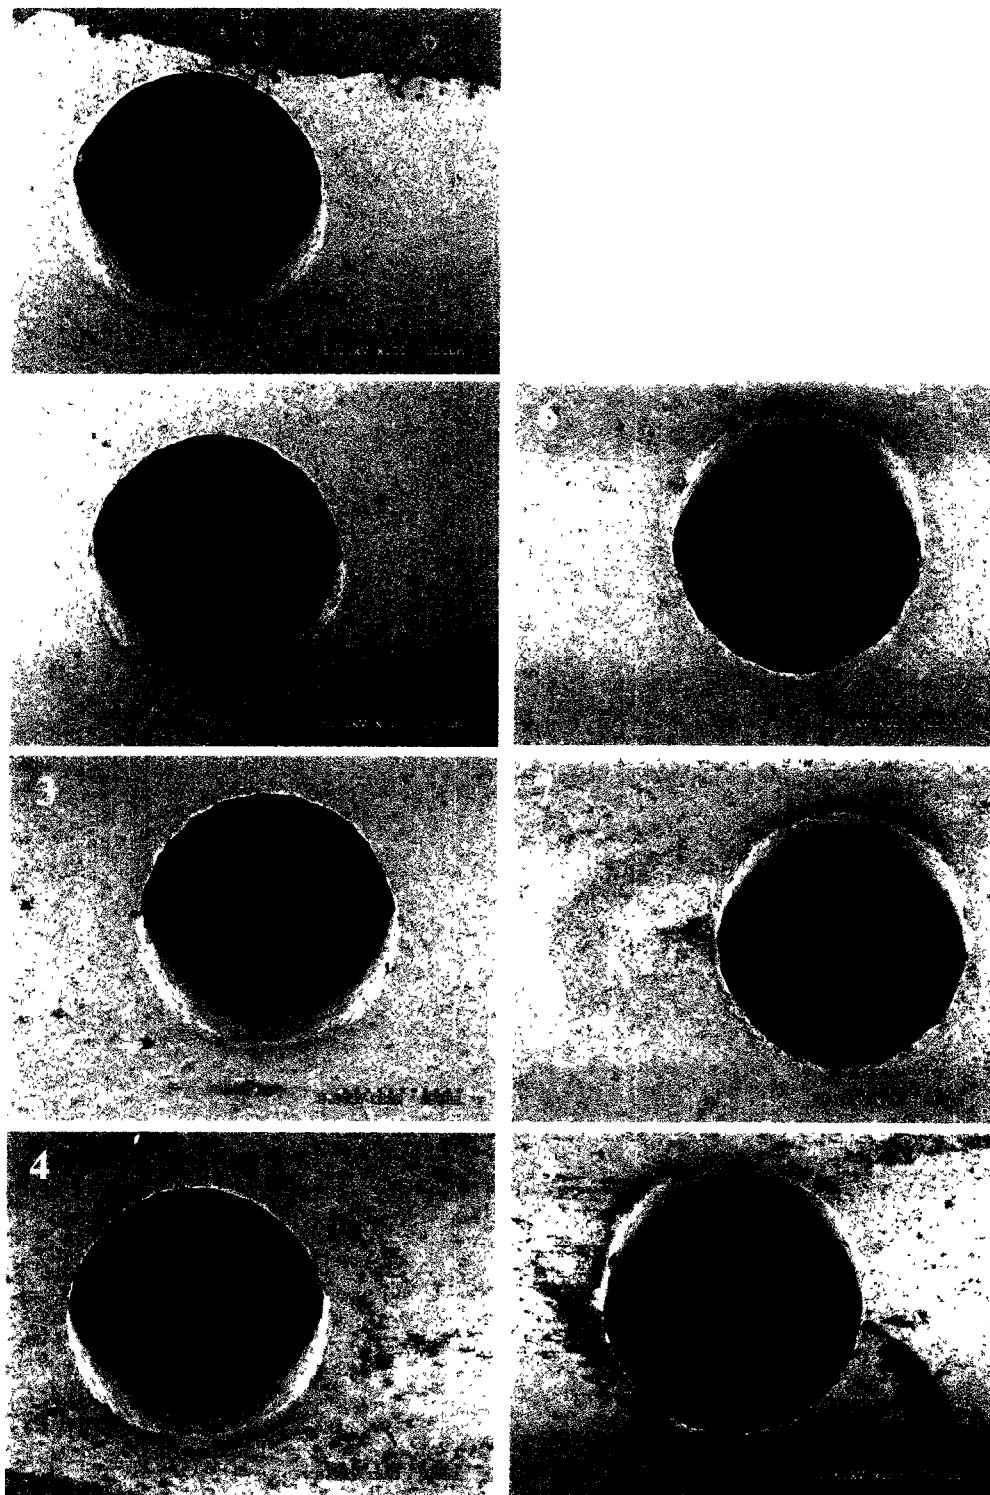
Figure 19. Series of images collected from Hitachi S3500N variable pressure scanning electron microscope in the areas of the pods on the **new Octopus 4[®] (MT-104-2)**. The images show uniform structure of the holes in the tubing. The numbers indicate the pod # (see Figure 5). Scale bar in each image.

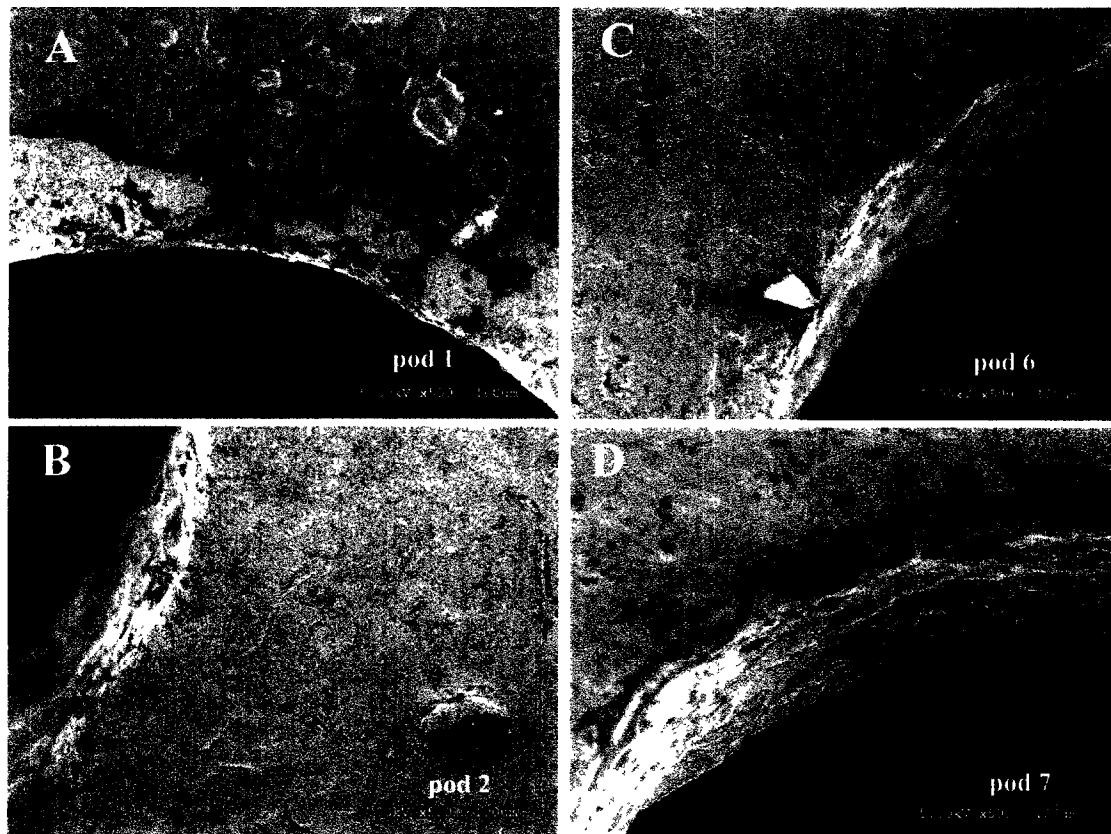
Figure 20. Series of images collected from Hitachi S3500N variable pressure scanning electron microscope in the areas of the pods on the **new Octopus 4[®] (MT-104-2)**. The images show structure of regions near the holes in the tubing from 4 of the 8 pods. The other pods show similar features. The numbers indicate the pod # (see Figure 5). Scale bar in each image.

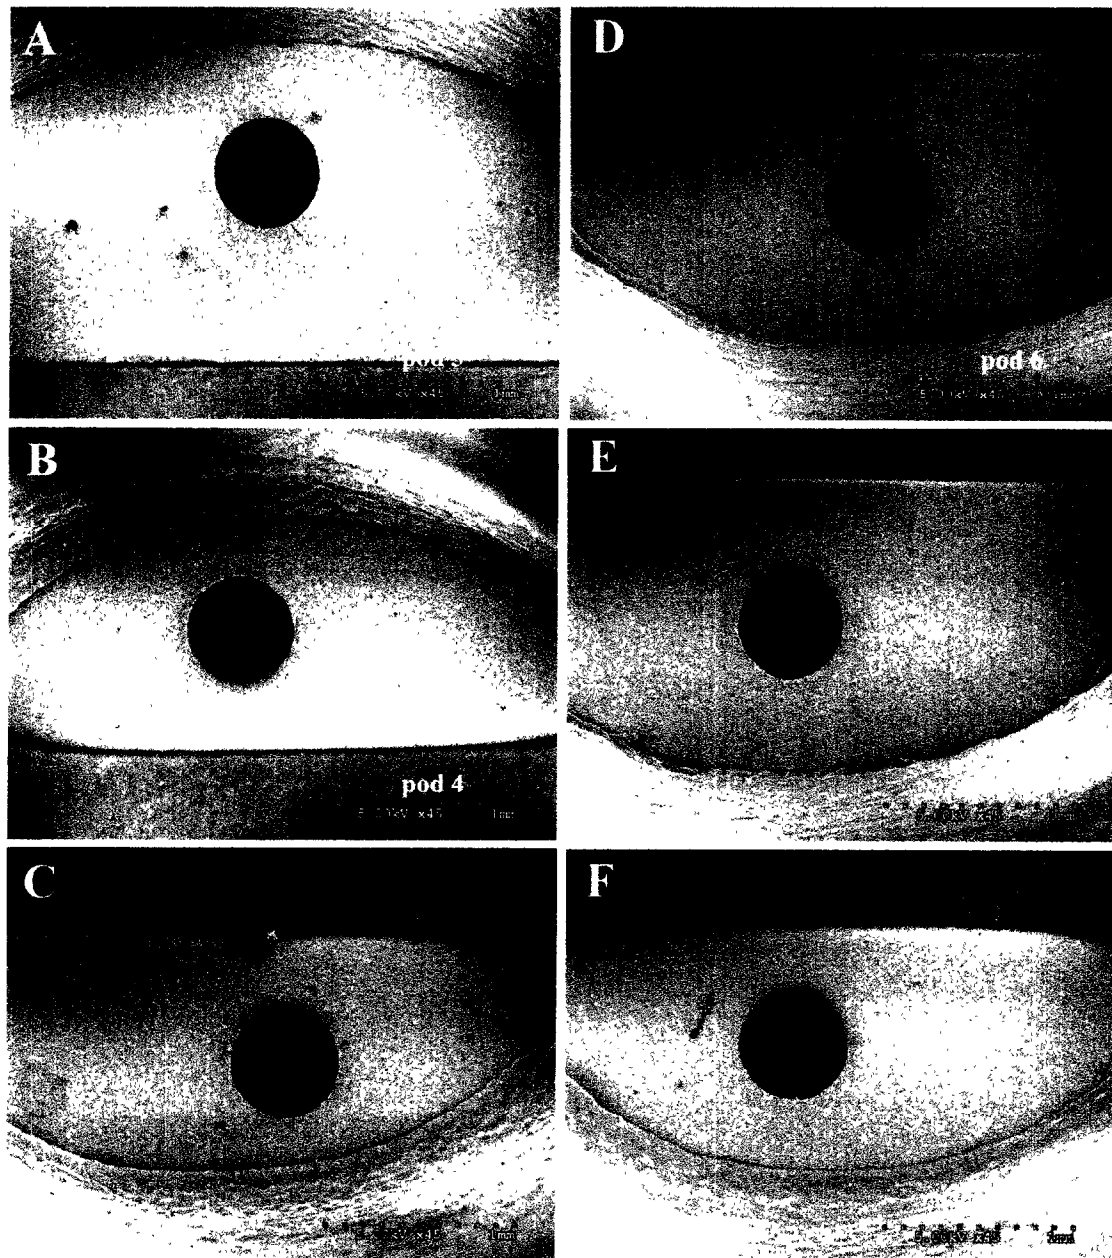
Figure 25. Series of images collected from Hitachi S3500N variable pressure scanning electron microscope in the areas of the pods on the **reprocessed Octopus 4[®] MT-104-4**. The images show uniform structure of the holes in the hypotube. There are what appear to be small pieces of the same material as the pod in some wells (e.g. pod #5 and #8). The numbers indicate the pod # (see Figure 5). Scale bar in each image.

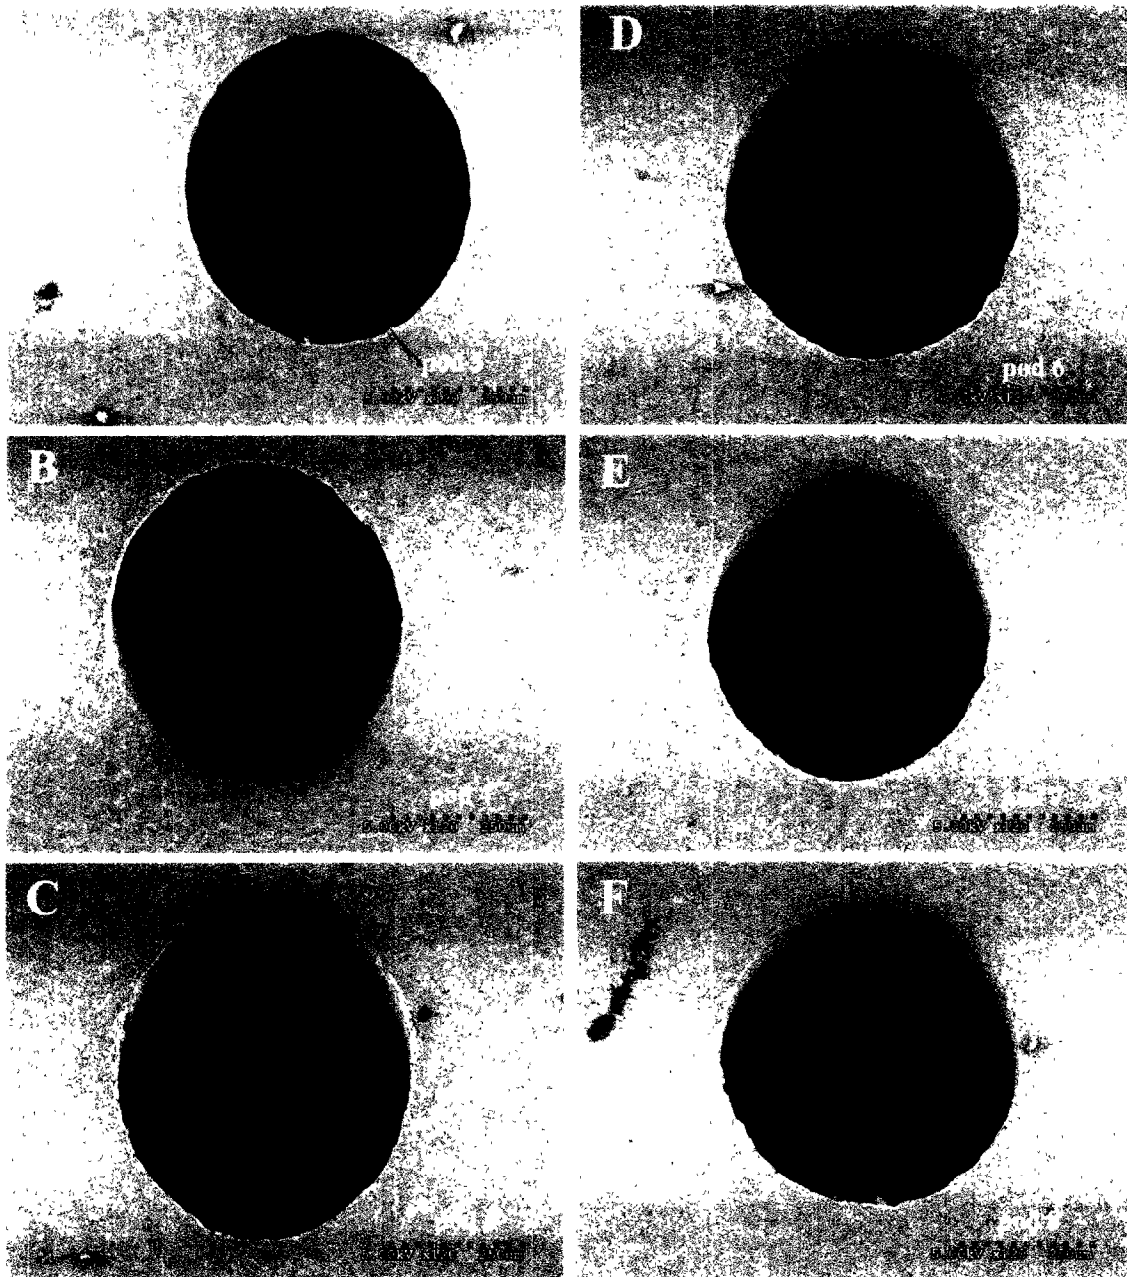
Figure 26. Series of images collected from Hitachi S3500N variable pressure scanning electron microscope in the areas of the pods on the **reprocessed Octopus 4[®] MT-104-4**. The images show uniform structure of the holes and hypotube surfaces. The numbers indicate the pod # (see Figure 5). Scale bar in each image.

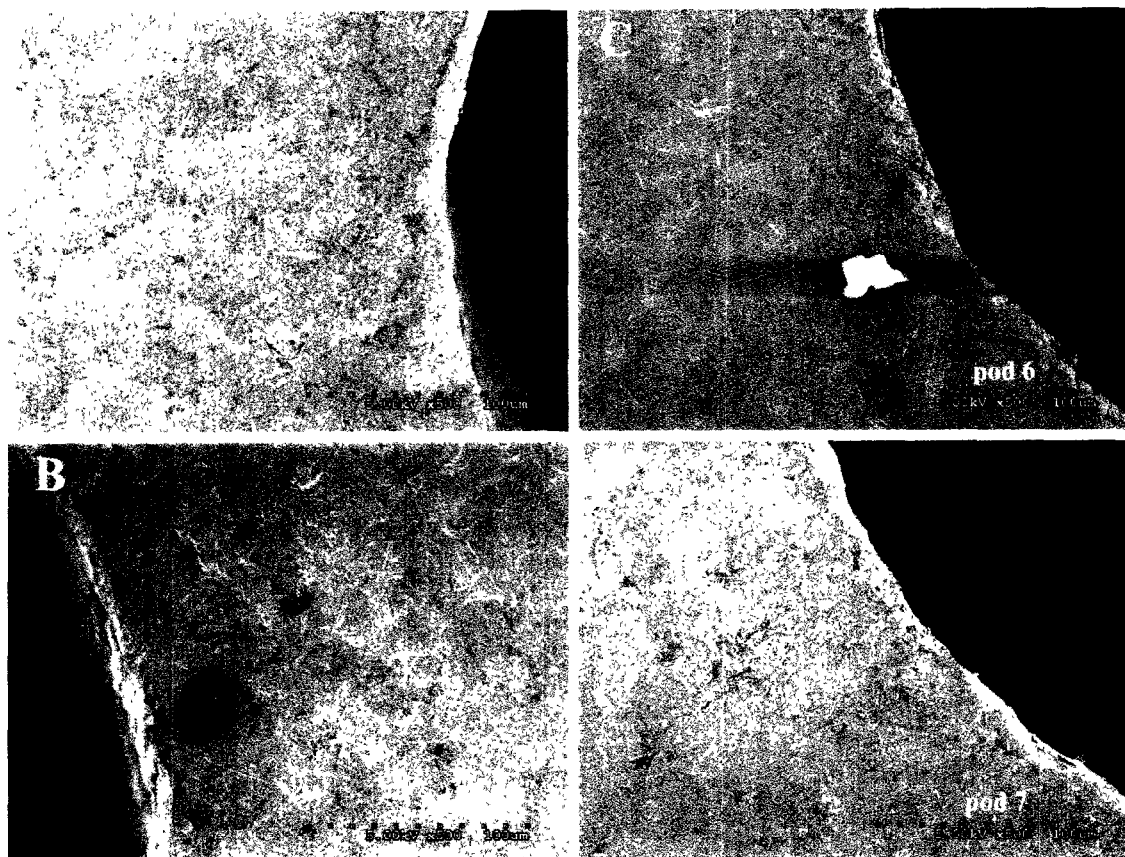
Figure 27. Series of images collected from Hitachi S3500N variable pressure scanning electron microscope in the areas of the pods on the **reprocessed Octopus 4[®] MT-104-4**. The images show uniform structure and inner and outer surfaces of the holes in the hypotube. The numbers indicate the pod # (see Figure 5). Scale bar in each image.

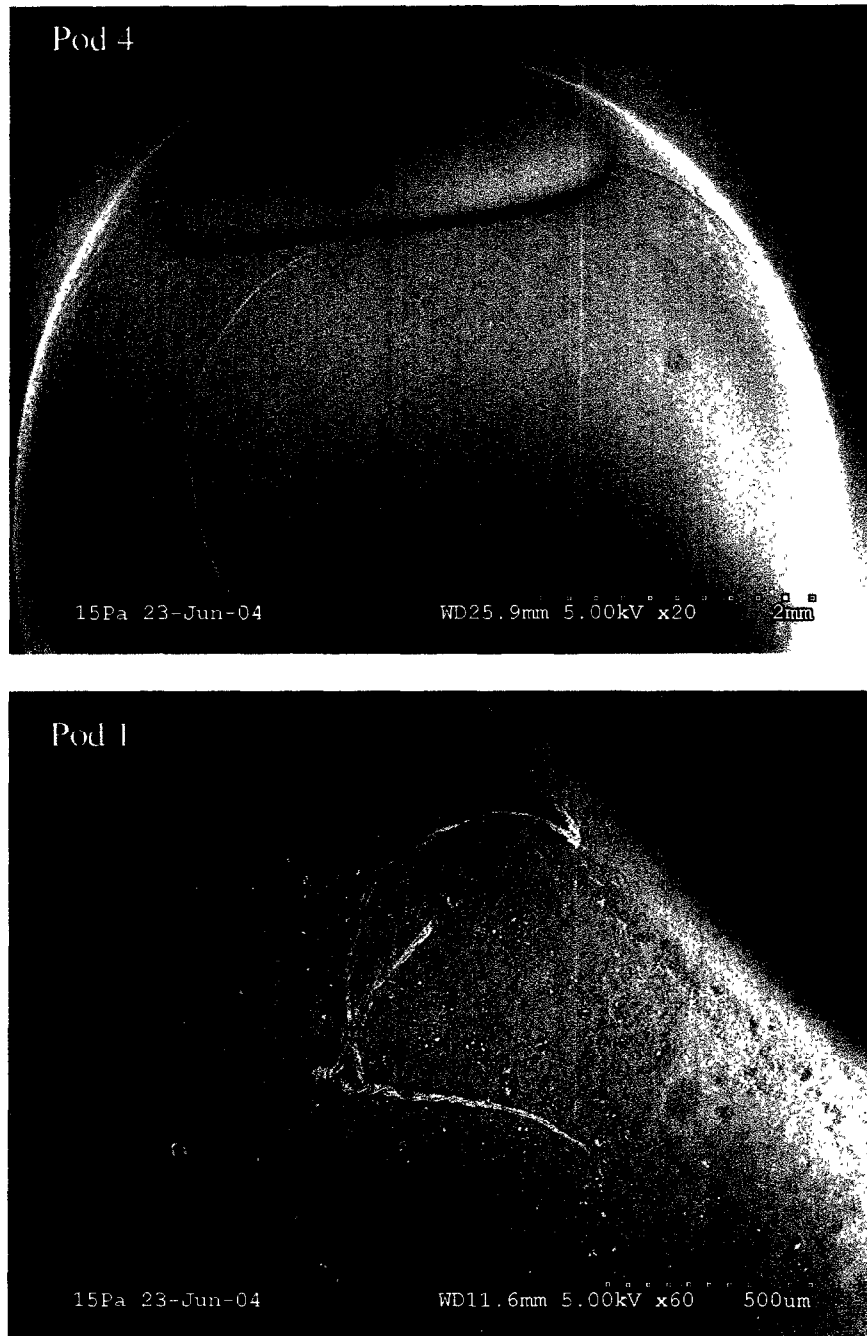
Figure 28. Images collected from Hitachi S3500N variable pressure scanning electron microscope in the areas of the pods on the **reprocessed Octopus 3[®] MT-104-5**. The images show hair-like fibers on surface of the hypotubing near the opening. There is also debris present in the surface of the tubing. The numbers in the upper left indicate the pod # (see Figure 5). Scale bar in each image.

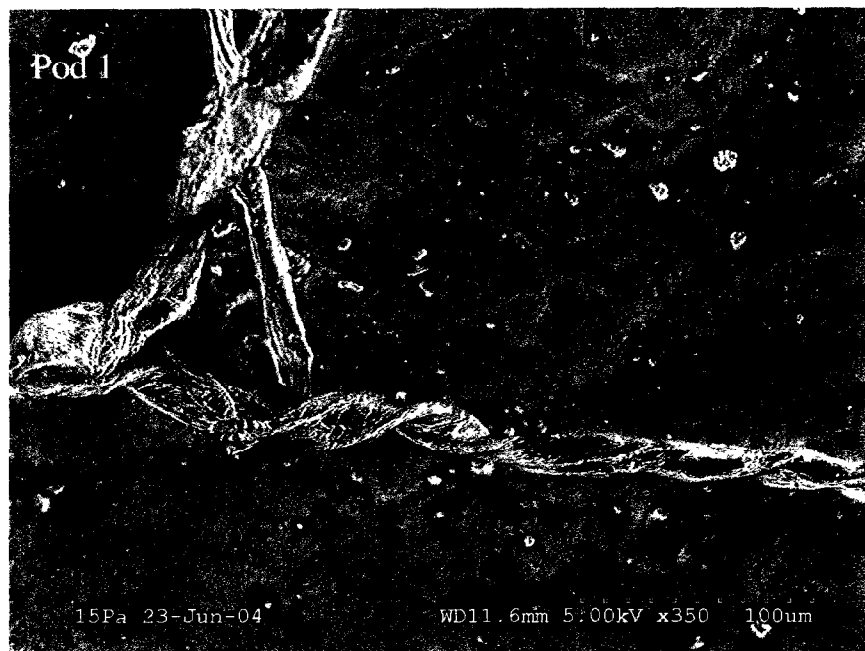
Figure 29. Image collected from Hitachi S3500N variable pressure scanning electron microscope in the areas of pod 1 on the **reprocessed Octopus 3[®] MT-104-5**. The images show hair-like fibers on surface of the hypotubing near the opening. There is also debris present in the surface of the tubing. The number in the upper left indicates the pod # (see Figure 5). Scale bar in each image.

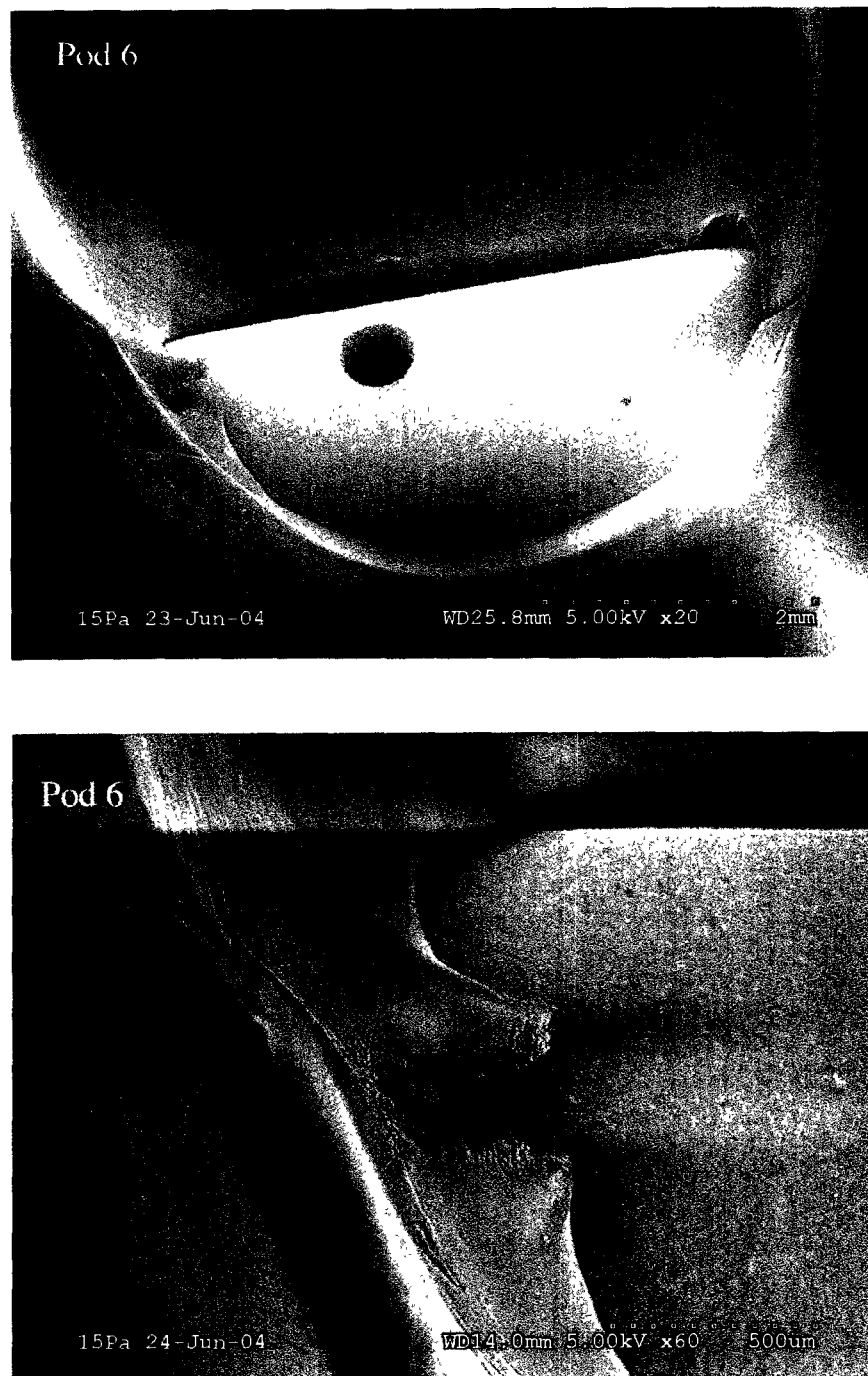
Figure 30. Image collected from Hitachi S3500N variable pressure scanning electron microscope in the areas of pod 6 on the **reprocessed Octopus 3[®] MT-104-5**. The images show a tear of the material surrounding the hypotube. There is also debris present in the surface of the tubing (upper panel). The number in the upper left indicates the pod # (see Figure 5). Scale bar in each image.

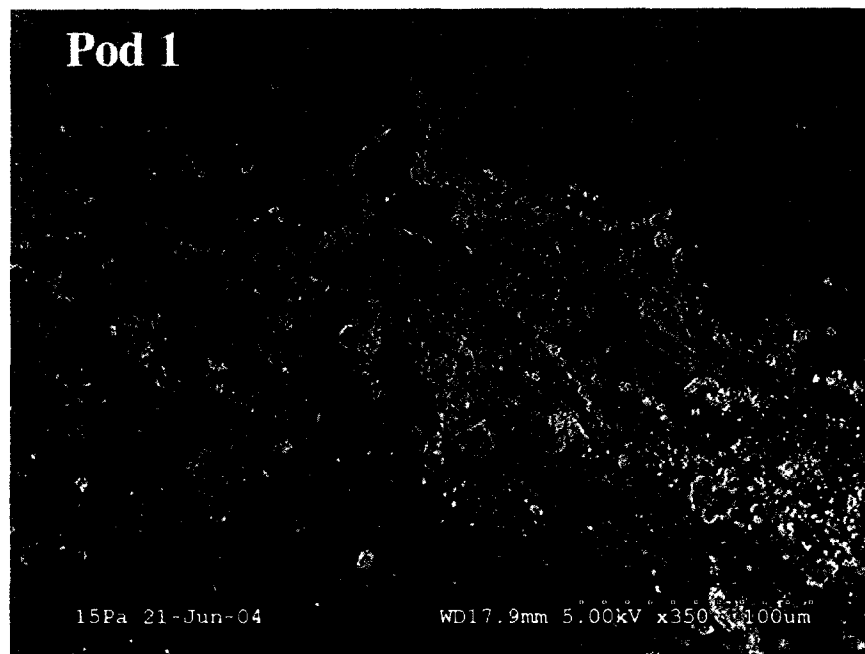
Figure 31. Image collected from Hitachi S3500N variable pressure scanning electron microscope in the areas of pod 1 on the **reprocessed Octopus 3[®] MT-104-7**. The images show debris on surface of the hypotube. The number in the upper left indicates the pod # (see Figure 5). Scale bar in each image.

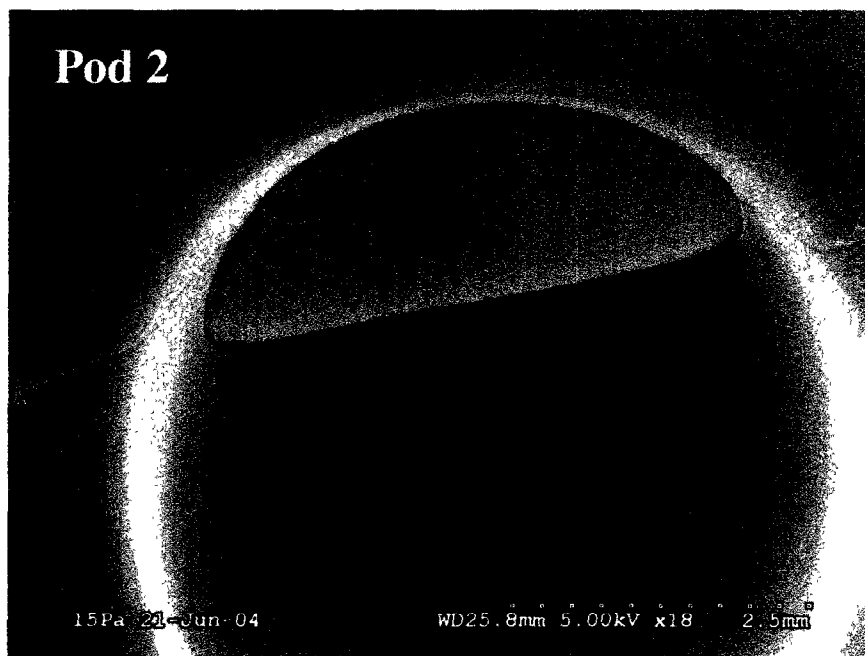
Figure 32. Image collected from Hitachi S3500N variable pressure scanning electron microscope in the areas of pod 2 on the **reprocessed Octopus 3[®] MT-104-7**. The number in the upper left indicates the pod # (see Figure 5). Scale bar in each image.

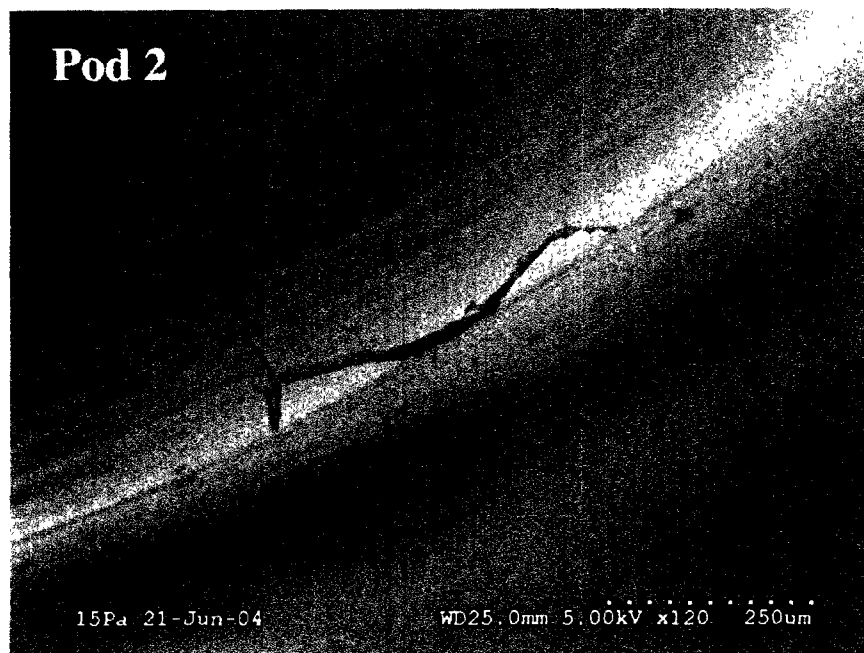
Figure 33. Image collected from Hitachi S3500N variable pressure scanning electron microscope in the areas of pod 2 on the **reprocessed Octopus 3[®] MT-104-7**. The images show hair-like fiber on surface of the pod. The number in the upper left indicates the pod # (see Figure 5). Scale bar in each image.

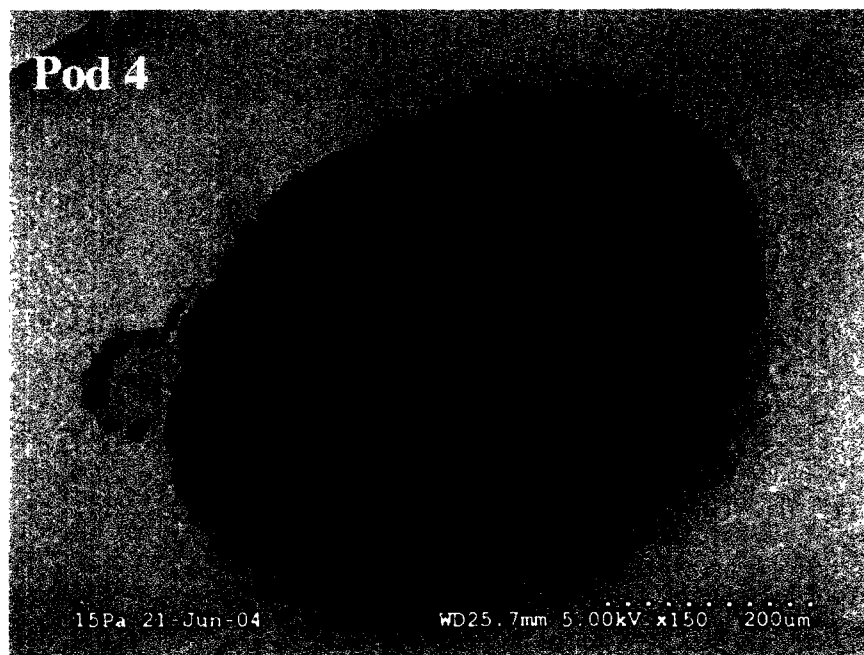
Figure 34. Series of images collected from Hitachi S3500N variable pressure scanning electron microscope of the tubing within pod 4 on the **reprocessed Octopus 3[®] MT-104-7**. Note material near the opening of the tubing orifice and the irregular shape. Scale bar in each image

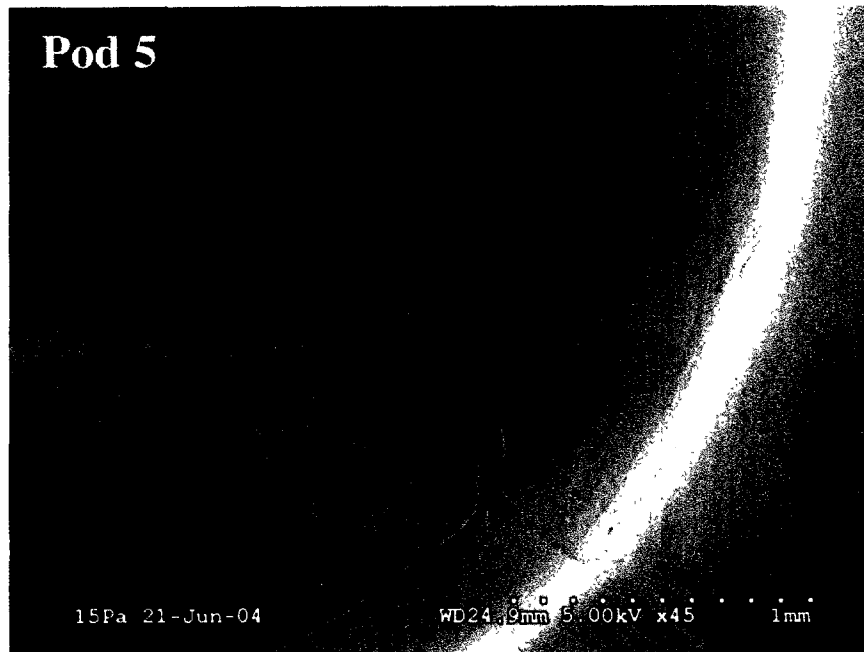
Figure 35. Image collected from Hitachi S3500N variable pressure scanning electron microscope in the areas of pod 5 on the **reprocessed Octopus 3[®] MT-104-7**. The images show a tear of the material surrounding the hypotube. There is also debris present. The number in the upper left indicates the pod # (see Figure 5). Scale bar in each image.

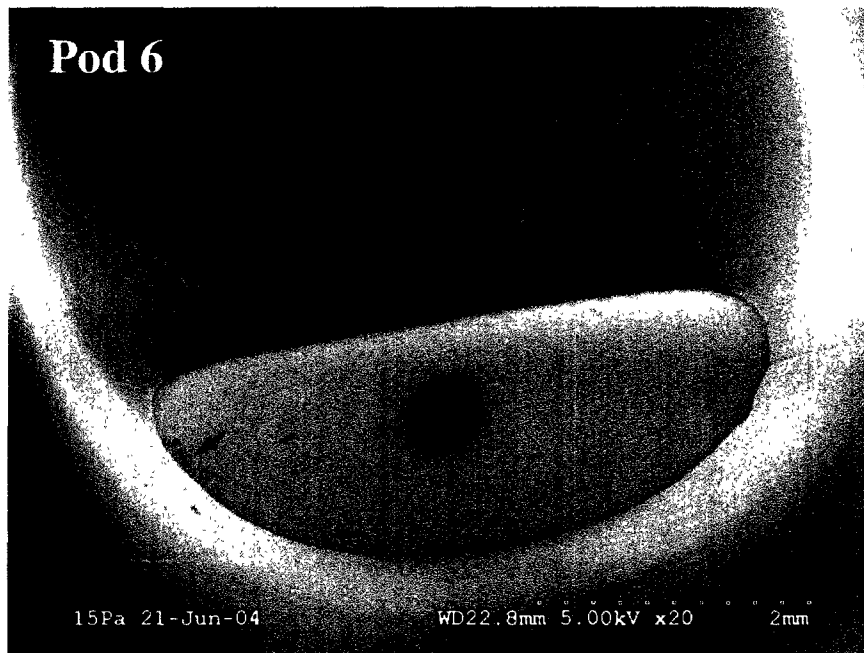
Figure 36. Image collected from Hitachi S3500N variable pressure scanning electron microscope in the areas of pod 6 on the **reprocessed Octopus 3[®] MT-104-7**. The images show a fiber (arrowhead) and debris on surface of pod and hypotube (arrows). The number in the upper left indicates the pod # (see Figure 5). Scale bar in each image.

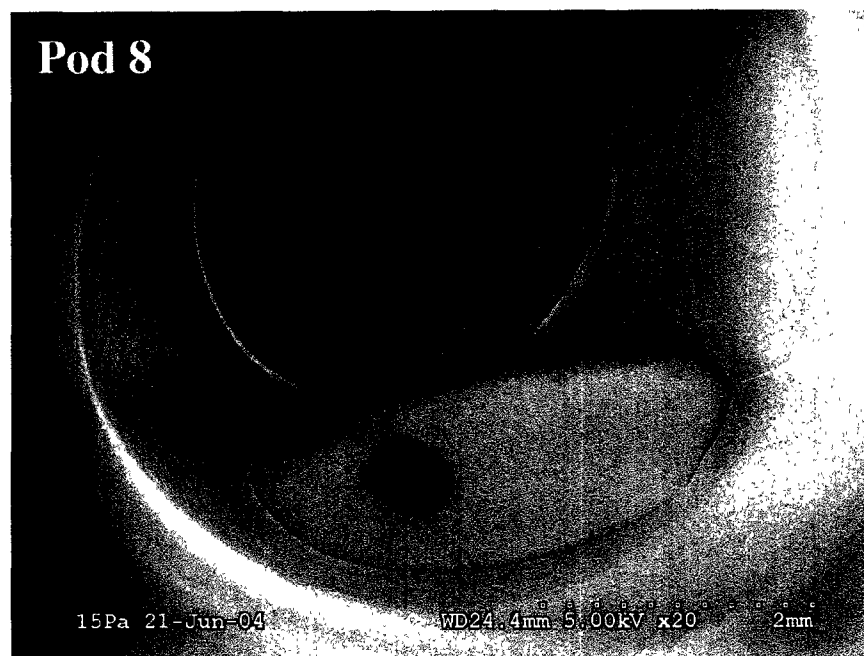
Figure 37. Image collected from Hitachi S3500N variable pressure scanning electron microscope in the areas of pod 8 on the **reprocessed Octopus 3[®] MT-104-7**. The images show debris on surface of pod and hypotube (arrows). Note gap between the hypotube and the pod. The number in the upper left indicates the pod # (see Figure 5). Scale bar in each image.

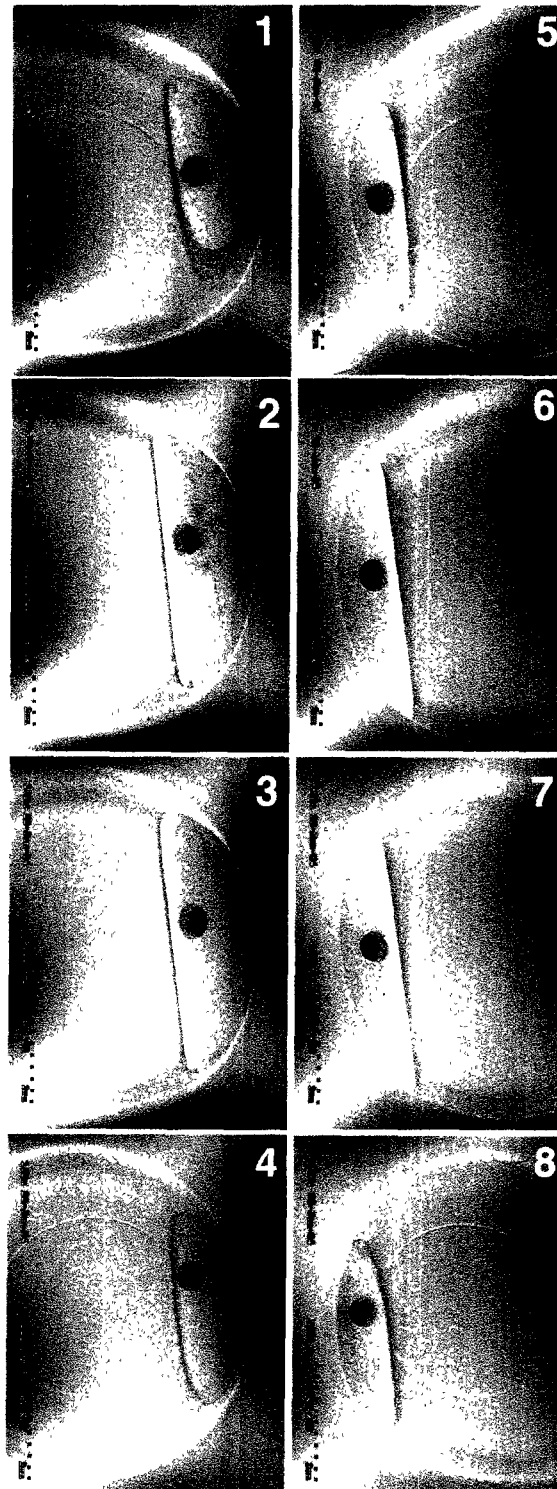
Figure 40. Series of images collected from Hitachi S3500N variable pressure scanning electron microscope in the areas of the pods on the **reprocessed Octopus 3[®] MT-104-9**. The images show irregularities on surface structure in the wells and tubing. There are irregularities and debris present in the orifices of the tubing. The numbers indicate the pod # (see Figure 5). Scale bar in each image.

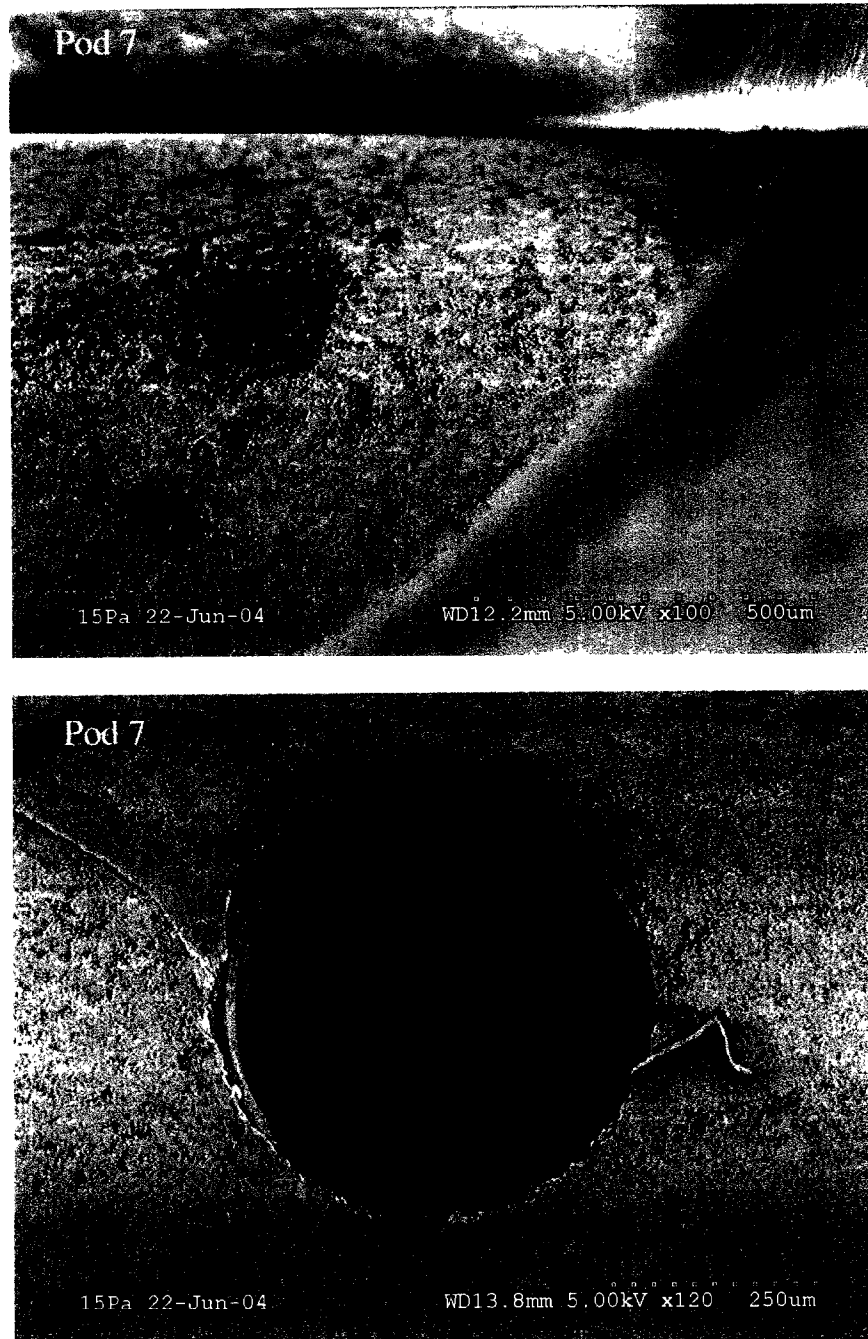
Figure 43. Series of images collected from Hitachi S3500N variable pressure scanning electron microscope in the areas of the tubing within the pods on the **reprocessed Octopus 3[®] MT-104-9**. The images show irregularities on surface structure of the tubing. There is debris and irregularities present in the orifices of the tubing. Note fiber near orifice and gouge near the opening of the hypotube. The numbers indicate the pod # (see Figure 5). Scale bar in each image.
